Explanation of photos

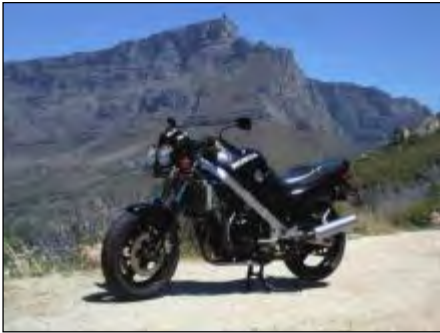
1

1. The bike the weekend before the accident. What I would like to draw your attention to is the way the generator protrudes approximately 120mm from the left side of the engine this cover is not damaged at all thus making it impossible for the damage to the clutch slave cylinder and engine drive sprocket. I have included a picture of a bike with the sprocket removed in the proper manner. My bike looks similar but bolts that could not be undone have been smashed off.

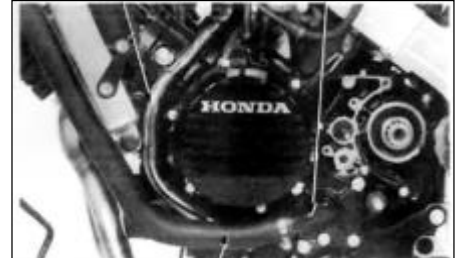
2

2. Sprocket removal. As can be seen the generator protrudes a considerable distance from where the parts have been removed. This is not a picture of my bike as I could not get access to photograph the left hand side of the bike. It's merely to explain my point.

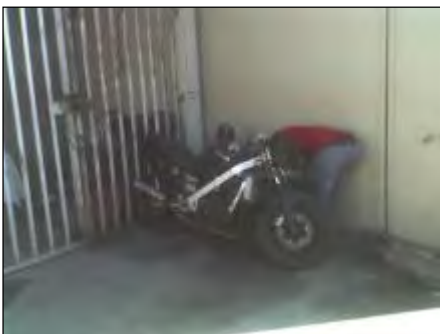
3

3. The bike in their yard about a month ago. Please note that the head lights have been removed, the plugs have been cut off completely. The rear indicator has been removed which can be clearly seen in the photo accident seen. The side covers have been removed and there is no sign of any oil leaking from the engine.

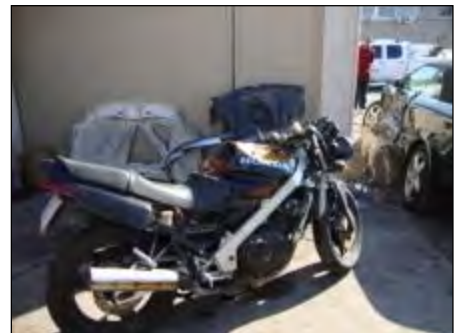
4

4. The bike as is was on Sunday 4th July 2010. There is oil leaking out under the bike, the battery has been removed. There are numerous bolts and screws loosened or missing and the battery removed the toolkit that was locked under the seat is also missing. I believe further damage to the petrol tank occurred when this was done as seat clips into the petrol tank in front and locks at the back.

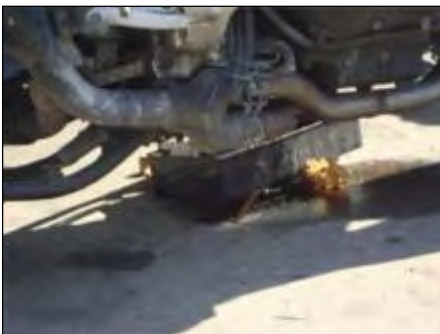
5

5. Close up of the oil leaking and the placement of a drip tray to try and catch the oil. This tray is not present in any of the earlier pictures which is proof that the engine was not leaking oil.
