Explanation of photos

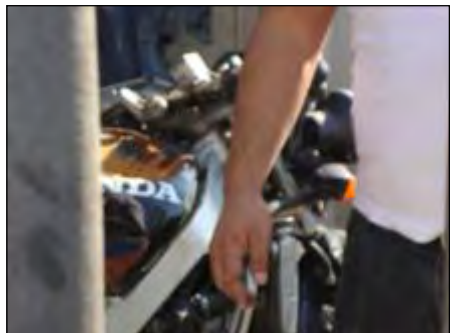
6

6. Chris Olieslager approaching while swearing at us. Did not get the chance to take a better picture as he started climbing the fence to as he put it f..k us up.
